Laser Cleaning of Grey Cast Iron Automotive Brake Disc: Rust Removal and Improvement in Surface Integrity

Keywords: Cast iron, laser cleaning, laser polishing, ablation, corrosion, surface integrity, automotive, brake disc

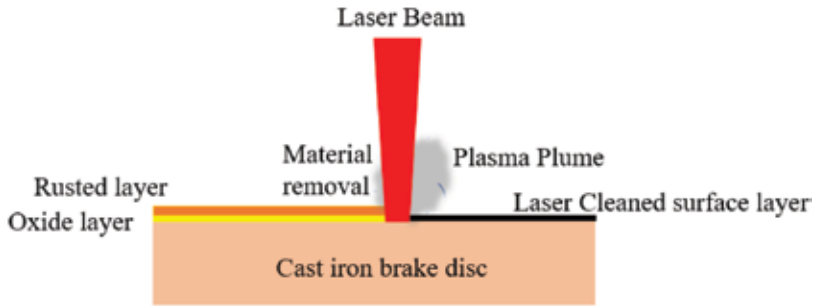
FIGURE 1
A schematic representation of laser rust removal process.

involve different mechanism for cleaning. A schematic representation of rust removal using a laser is shown in Figure 1.

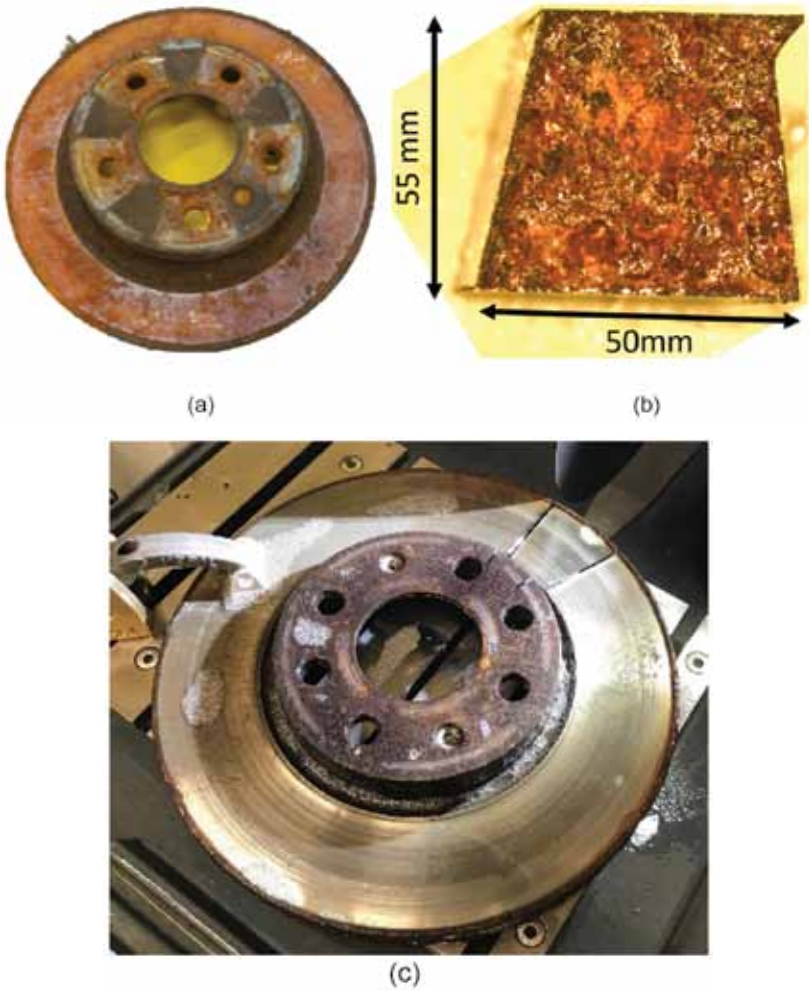
FIGURE 2
Illustrates optical images of the rusted brake disc in (a); a cut bake disc into smaller parts in (b) and (c) the un-rusted automotive brake disc.

this experiment. The brake disc was exposed to the atmosphere to enable moisture (water and air) to act on it for several weeks. By the third week significantly, uniform rust was formed throughout the entire surface of the brake disc as seen in Figure 2. The uniformly rusted brake disc was then cut into 20 parts (samples) of roughly equal size to ensure that samples were sufficient for the experiment. Figure 2(a) shows the rusted brake disc and the cut sample into smaller parts prior to laser cleaning in Figure 2(b) and the un-rusted complete brake disc in Figure 2(c).

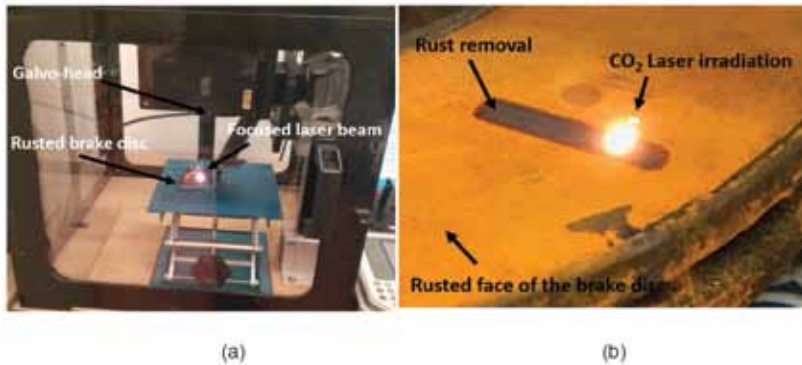
FIGURE 3

Optical images showing experimental set-up of the CO₂ laser rust removal process in (a) and method of rust removal in (b).

Laser cleaning experiments were conducted using a continuous wave (CW) Rofin multiscan CO₂ laser (Hamburg, Germany). The laser has a wavelength of 10.6μm and a maximum power output of 85W. Experimental parameters applied and varied are namely: laser power, traverse speed, and spot size (see Table 1). A systematic approach was adopted for the experiments where one parameter was changed in an orderly pattern while other parameters were kept constant. The experiment involved 20 different samples with a total of 27 trials each processed with a unique set of processing parameter. First, the power was varied between 10W to 85W (maximum power), while other parameters were kept constant. The Radiance density (brightness) was determined using our previous technique [40 – 42], and ranged from 2.74 to 132.35 W/mm²/Sr⁻¹/μm⁻¹. Traverse speed was varied between 30 to 3000mm/s with other parameters kept constant. The focal distance was also varied to obtain the correct laser beam diameter. Each of the cut samples were mounted on the processing table and exposed to the CO₂ laser beam to remove the top rust surface (see Figure 3(a)). Figure 3 also shows the experimental set up during the laser cleaning process and the method of rust removal.

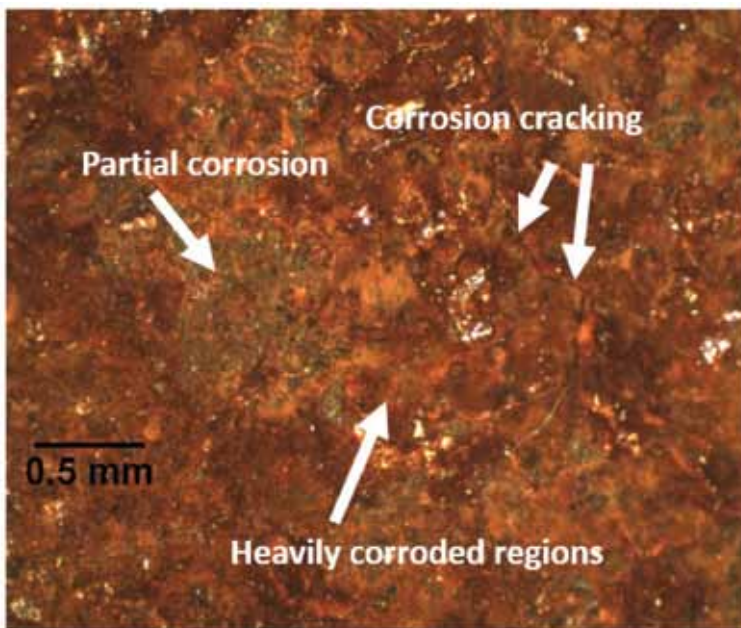
FIGURE 4

Optical image of the rusted (untreated) surface of grey cast iron brake disc.

Figure 4 represents a rusted surface which was removed by varying the laser parameters. The constituent of the rusted surface includes heavily corroded regions, corrosion cracking, and some areas that are partially rusted. The alteration of laser power from 10 to 85W (max power) produced various level of rust removal. At 10W, it was observed that a very low level of rust was removed with no visible cleaning effect. As the laser power was ramped up to 20W, the effect of rust removal became visible, but surface still contained significant rust. Upon applying 30W to 40W of laser power, there was a moderate level of rust removal. As the laser power was increased to 50W, there was a considerable amount of rust removed. At 60W, the rust removal was increased, but still contained areas where rust was visible. Although, it offered the best effect as ramping up the laser power to 70W significantly removed the rust but also affected the base metal. Thereafter, the rust was removed but the base metal was considerably altered due the increased laser power applied, and the substrate becomes visible with melt zones as evident in Figure 5(a), (b) and (c).

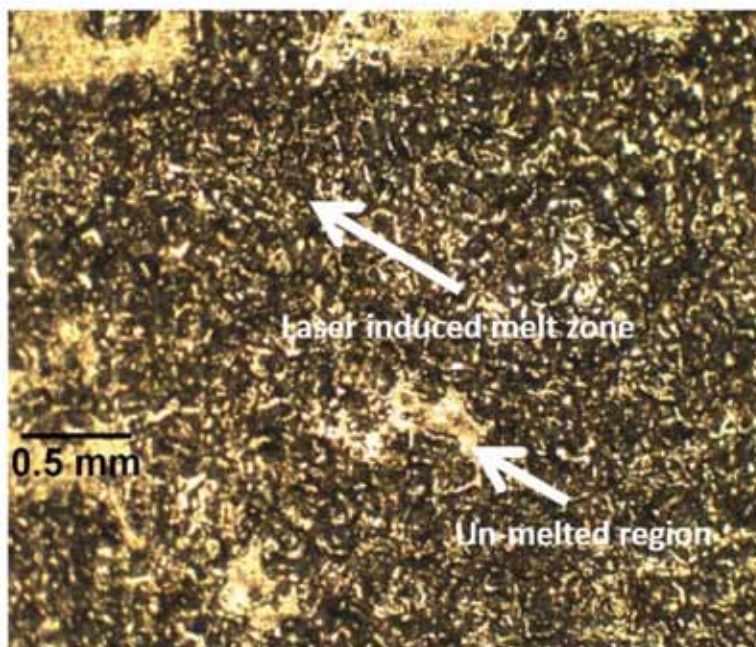
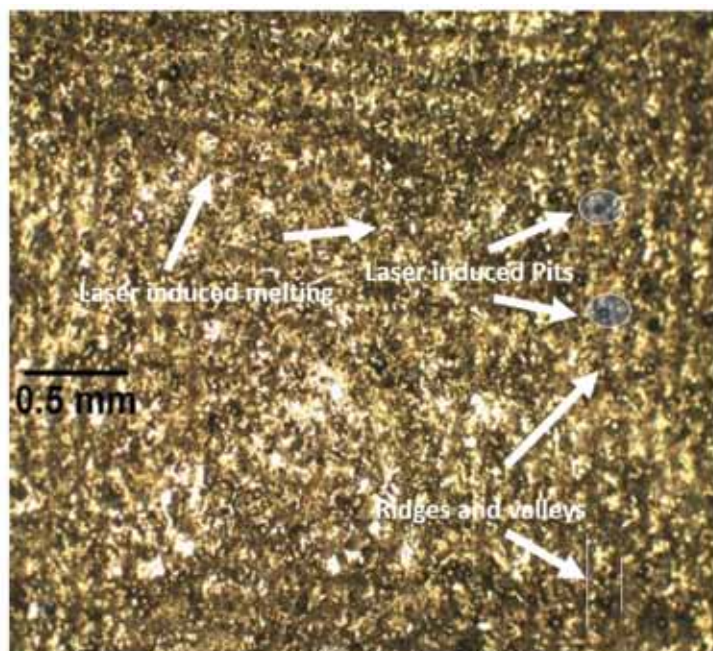
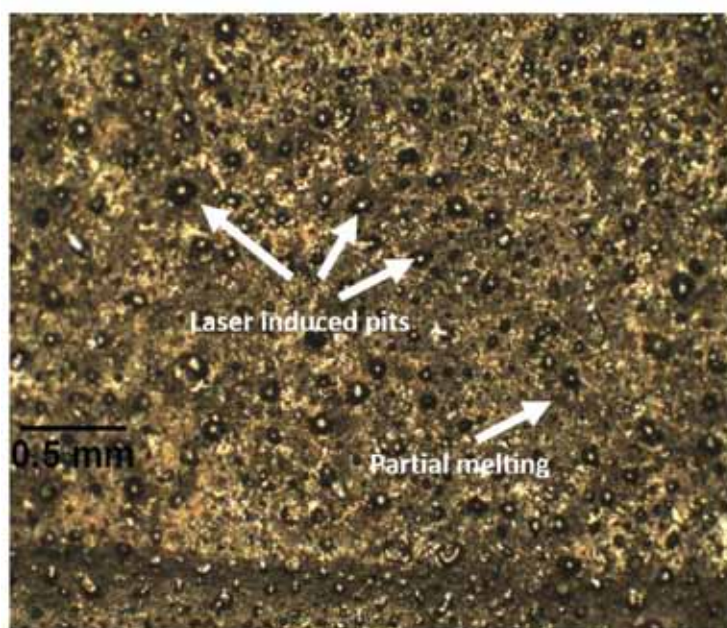
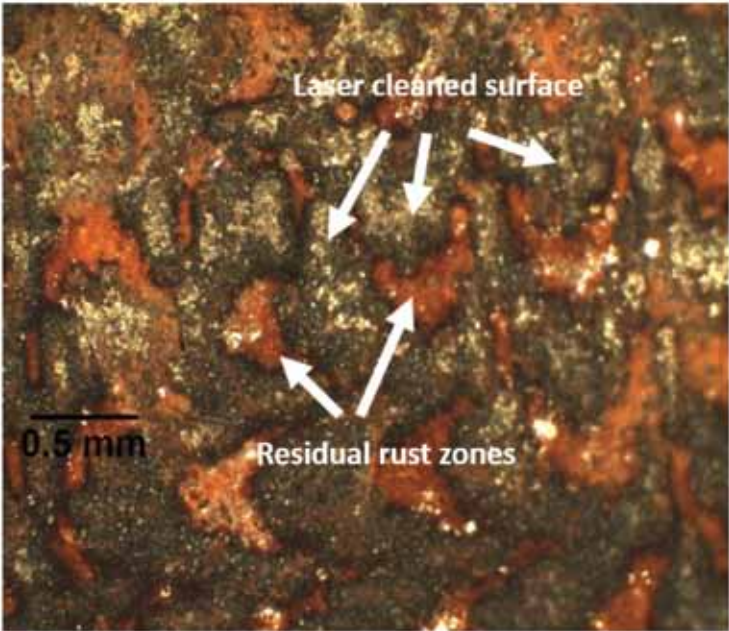
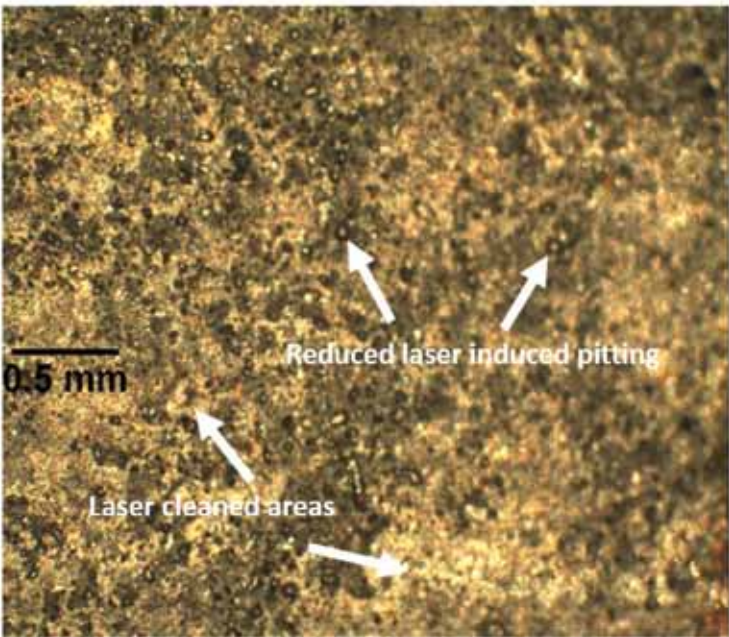
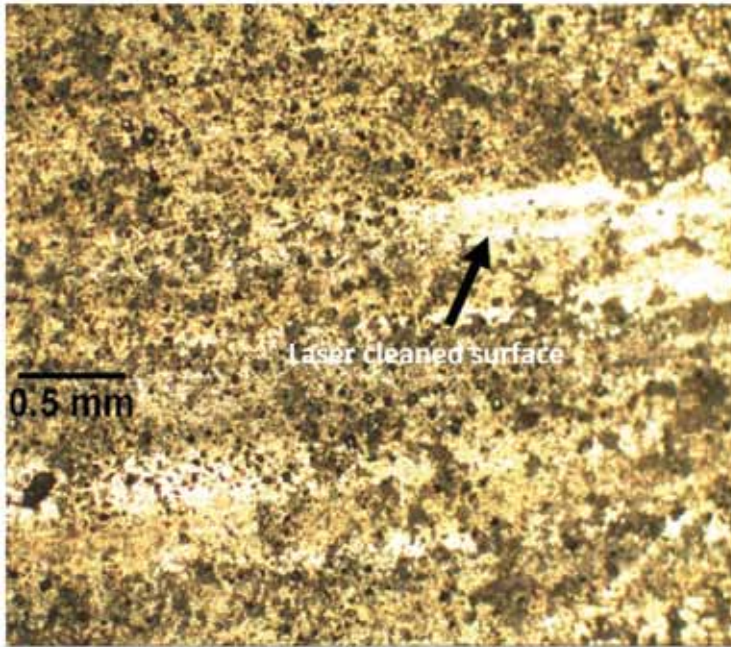
FIGURE 5

Optical images of laser cleaned surfaces in (a) at 30mm/sec; at 300mm/sec in (b); at 600mm/sec in (c); at 2000mm/sec in (d) whilst using a spot diameter of 0.72mm and laser power of 60W. (E) and (f) showing the most appropriate laser cleaned surfaces with a spot diameter of 0.72mm and laser power of 60W at 9000mm/sec.

As mentioned, increasing the laser power to 60W resulted to the best laser cleaned surface and will be further applied (Figure 5(e) and (f)) whilst varying the traverse speed. The best laser cleaned sample after varying all the parameters was 60W, 900mm/s traverse speed and 0.72mm spot size as all the rust were removed and the metal substrate was not melted (see Figure 5 (e) and (f)). Figure 4 demonstrates a direct comparison between the rusted (untreated) sample and the laser cleaned surfaces in Figure 5 (a) to (f).

Laser power (60W) and a spot size of 0.72mm was kept constant while the traverse speed was varied. Variation between 30mm/sec to 100 mm/sec produced total removal of rust, but the base metal was badly affected due to very low traverse speed which was due to the high laser power acting on the grey cast iron brake disc for a prolonged period which caused considerable melting. This would not be desirable as it is then likely that some of the surface properties would have changed. For the application of a brake disc, modification in the material's surface integrity was not an objective since it will affect the functional capabilities of the brake disc. At 200mm/sec to 300mm/sec traverse speed, there was complete rust removal while the melting of the base metal reduced. At 500mm/sec to 700mm/sec traverse speed, there was mini-

mal melting of the base metal associated with good rust removal. As the speed increases, melting of the base metal decreases. At 900mm/sec, there was excellent removal of rust, and base metal was not affected which is rather desirable. At 1000 mm/sec, a good level of rust removal with little rust particles still seen on the surface. Beyond this speed (1500, 2000, 3000 mm/sec) rust was not removed to any considerable effect as the traverse speed was too fast to create any heating, local melting and material removal.

The rusted brake disc has a slightly varying thickness of corrosion as it was exposed to the atmosphere. However, several measurements were taken at various points on each sample and the average was calculated. Hence, the mean represents the most accurate thickness value. Table 2 shows the average thickness of the surfaces with three different conditions. It was observed that the average thickness of the rusted layer was 0.33mm compared to the unrusted surface. The thickness of the laser cleaned surfaces is shown in Table 2 as well as the depth of the rusted layer removed in Table 4. During the experiment, the cast iron brake discs were subject to high local temperatures generated from the laser beam operation at high power and or low traverse speed. Hence, it becomes unnecessary to measure the amount of rust removed after the top surface was melted and solidified, leading to the formation of melt zone, and pits, and dimples, as evident in some of the optical images in Figure 5(b) and (c).

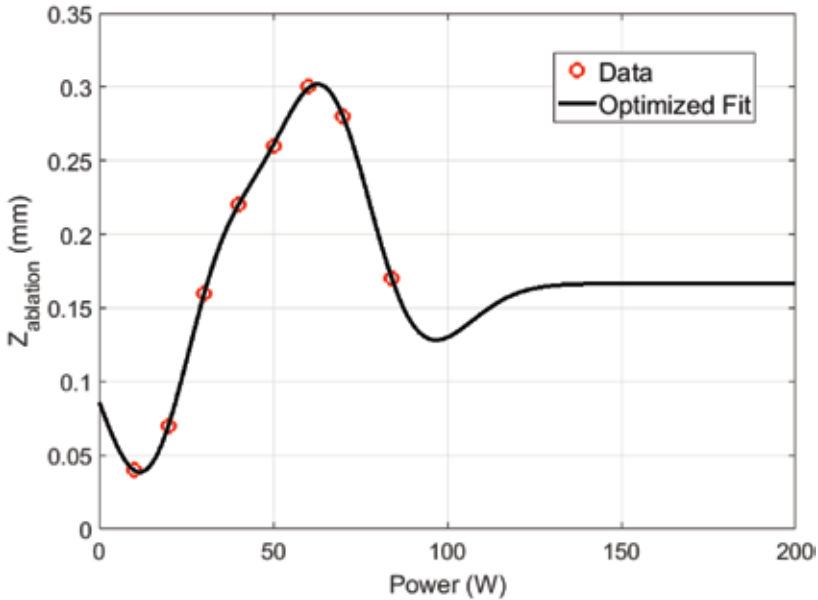
FIGURE 6

Experimental data with optimized fit for laser power *versus* Z-ablation obtained with the Gaussian process regression method.

The GPR curve determined using the experimental data (laser power *versus* Z_{ablation}) combined with the optimized fit is shown in Figure 6. It is clear that an increase in laser power had increased the Z_{ablation} which peaked at 60W with 0.30mm in thickness of rust removed. The value of Z_{ablation} begins to decrease beyond this point and can be postulated (from Figure 6) to saturate where the ablation depth becomes considerably constant as the laser power increases to 200W. The dip in the curve is difficult to

explain at this stage, but it can be given to the lack of experimental data which reduces the reliability of the GPR method. Reliability would improve with further experimentation which would verify and support the predicted GPR curve.

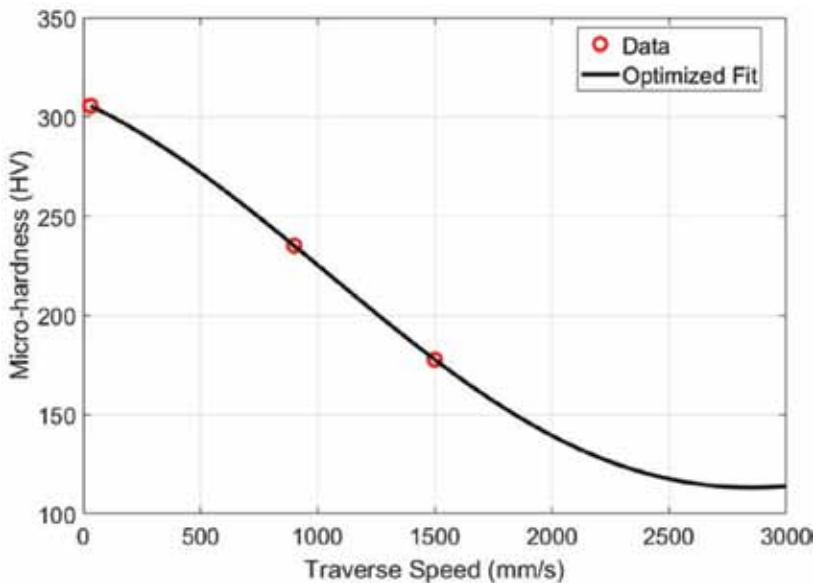
FIGURE 7

Gaussian process regression optimized curve and experimental data of microhardness *versus* traverse speed.

hardness with the lowest laser cleaning traverse speed. The lowest traverse speed comprised of the highest hardness which was an increase by 37% in comparison to the un-rusted surface and over 3 folds increase, compared to the fully rusted surface. Creek [19], suggested that rust reduces the hardness and strength of metals. That is, as the amount of rust reduces, hardness increases. Furthermore, as the traverse speed increased the hardness decreased. At 900mm/sec, the hardness was measured at an average of 235HV which was about 4.5% in comparison to the un-rusted surface. The traverse speed was increased to 1500mm/sec and the hardness was measured to be 178 HV. This was the lowest obtained from the laser cleaned surfaces. This was attributed to the fact that higher traverse speeds does not result in enough rust being removed from the respective surface. This lead to the hardness still not measuring close to the un-rusted surfaces. Tabulating these parameters into the GRP curve also yielded similar findings, whereby, the hardness reduced as the traverse speed increased (see Figure 7). As the laser beam was active for a longer period on the rusted surfaces. Particularly at low traverse speed (30mm/sec), there was significant heat being generated at the laser-material interaction. Thus, the possibility of removing the rust was not only high as evident from Figures 5, but also producing partial melt-zones which solidified at a slower rate to have generated a ductile surface. Also, the surface partial-solidification induced ductility would

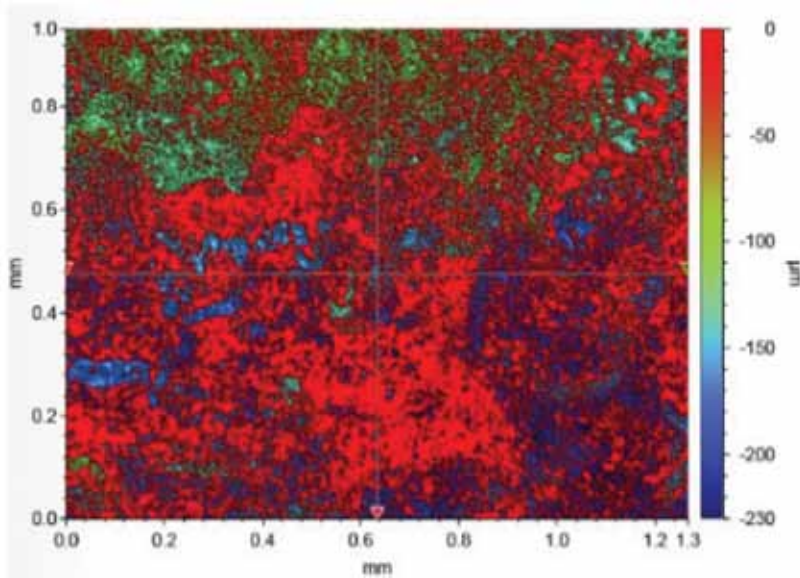
FIGURE 8
Topography of rusted grey cast iron brake disc surface.

surface. The 2-D topographical images of the rusted, un-rusted and totally cleaned samples are illustrated in Figure 8 to Figure 10 respectively. From Figure 8 to

Figure 10, it is was seen that the rusted sample 2-D topography has less smooth surface when compared to the other two samples. The existence of pits, ridges and valleys might have influenced such topography.

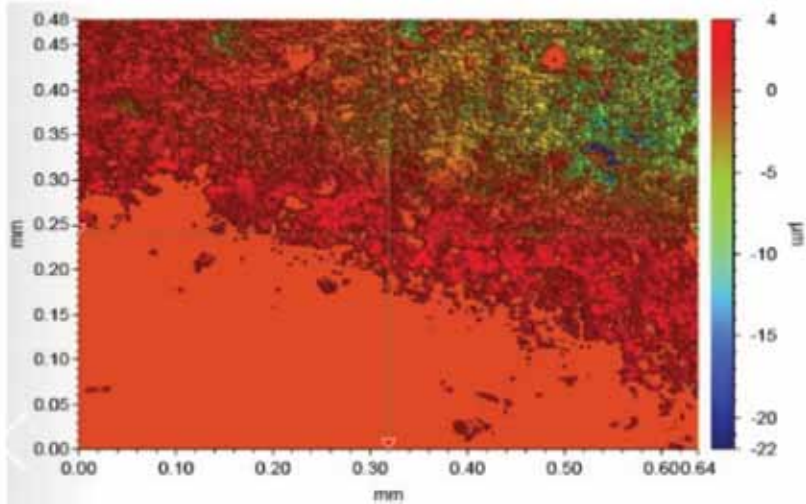
FIGURE 10
Topography of laser cleaned grey cast iron brake disc at 60W laser power, 900mm/sec and 0.72mm spot size.

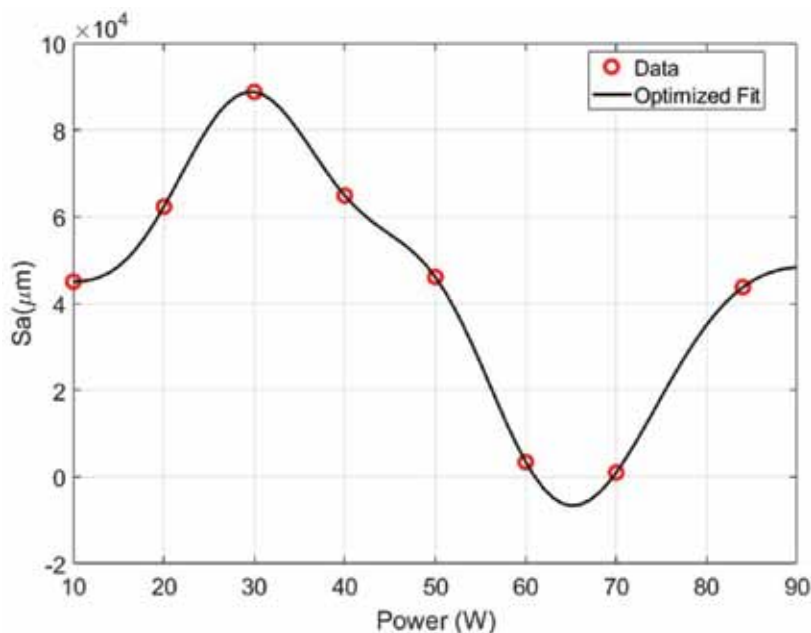
FIGURE 11

Illustrating the S_a values with respect to increase in power (60W laser power, 900mm/sec traverse speed and a spot size of 0.72 mm).

Upon observing the S_a values, it was evident that as the laser power increased, the S_a value increased simultaneously until it peak at 30W, then subsequently decreased as the laser power further increased (see Figure 11). This indicated that the surface was smoothening as the roughness was reduced with the rusted layer being removed. At 60W the roughness was at the lowest with a possibility of complete removal of the rust. The roughness then began to increase as the laser power went up. This indicated that there was a possibility of surface melting and reforming to form a new rougher topography. This was also evident from the optical images showing melt zone beyond the laser power of 60W. As the surface considerably melted, it created dimpling and pitting effects, evident in Figure 12. This created an increase in surface roughness as evident from Figure 12 where the S_a values noticeably increased.

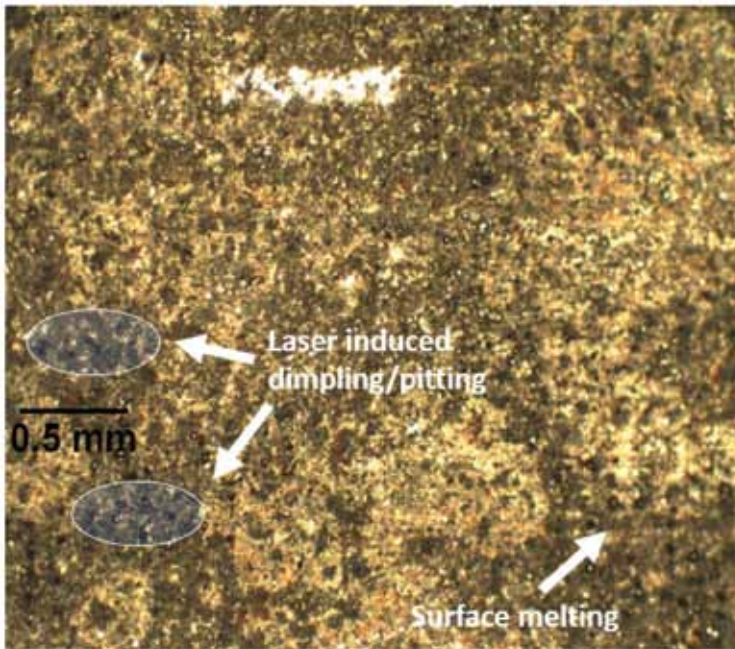
FIGURE 12

Showing the roughening of the surface at 70W laser power, 900mm/sec and 0.72 mm spot size as melt zones take place in various area.

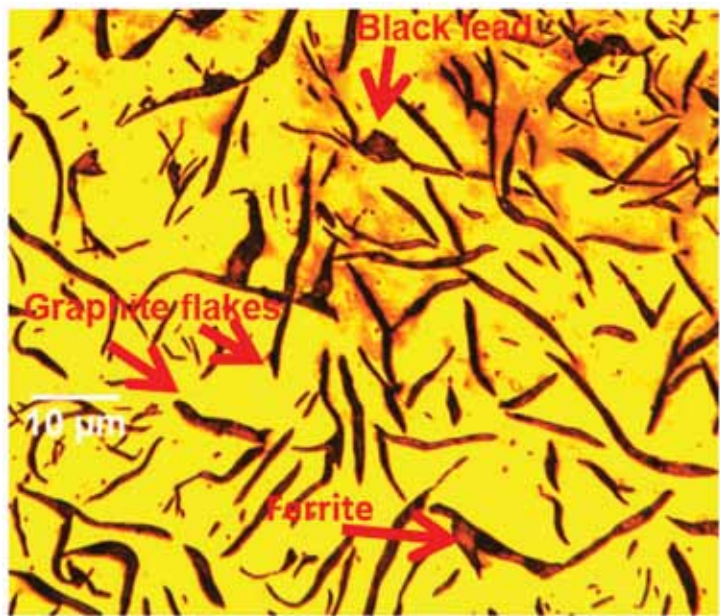
FIGURE 13
Microstructure of the un-rusted surface of the grey cast iron.

three surfaces all show the presence of a black flake-like structure (graphite flakes). Grey cast iron is characterised for having a large portion of its carbon in the form of graphite flakes. The fast interstitial diffusion of small carbon atoms makes the formation of graphite flakes possible. As diffusion progresses, more graphite is formed. The plane of such graphite is held by a covalent bond and has a hexagonal structure. The presence of silicon as one of the alloying elements of grey cast iron promotes the formation of ferrite and graphite. It acts as a strong graphitizer during eutectic solidification of grey cast iron. Eutectic cells are formed by the nucleation of graphite. The mixture of graphite and austenite makes up the eutectic cells. The eutectic cells can be viewed on the micrograph chemical etching. During the eutectoid transformation, the austenite transforms into ferrite and cementite or graphite. The system stability is dependent on the transformation that occurs. Graphite or cementite either occupies the carbon-rich zone based on the system stability, that is, if the system is metastable, it prefers cementite. If the system is stable, it prefers graphite. The graphite flake is seen to be much softer than the surrounding matrix which is viewed as a void. The formation of the pearlitic matrix with graphite particles occurs in the surrounding matrix of the flake to prevent the structure from being too weak. This formation

gives it good compressive strength, good thermal conductivity and vibration damping. It was observed from the microstructure that the graphite flakes vary in shape and size. The rusted sample shows larger flakes when compared to the un-rusted and laser-cleaned surfaces. It also exhibits relatively longer graphite flakes on the average. Deep black pits are also seen on the microstructure of the rusted sample which signifies the presence of impurities and non-metallic inclusions. The presence of inclusions and impurities along with the slightly longer and larger graphite flake is responsible for the low hardness value and high Ra value of the rusted sample.

length created lesser space for a hard pearlitic matrix. The grey region in Figure 13 to Figure 15 represents a pearlitic matrix. The pearlitic matrix contained two phases which are ferrite and cementite. While cementite is a hard and brittle intermetallic compound, ferrite has low strength and high ductility. Besides the cementite found in the pearlite matrix, the micrograph also showed no evidence of cementite. The dual phase involving ferrite and cementite which creates the pearlitic matrix originates from the austenite phase. At higher temperature, only austenite is present with 0.76% C been dissolved in the face-centered cubic (FCC) crystal's solid solution. The cooling down of iron to 727°C results in several simultaneous changes. It is highly likely that the laser cleaning process induced temperatures above that level. First, the iron changes from FCC austenite to body-centred cubic ferrite, but the ferrite can only accommodate 0.022% carbon in solid solution. The excess carbon left was then rejected forming the carbon-rich intermetallic phase which is cementite.

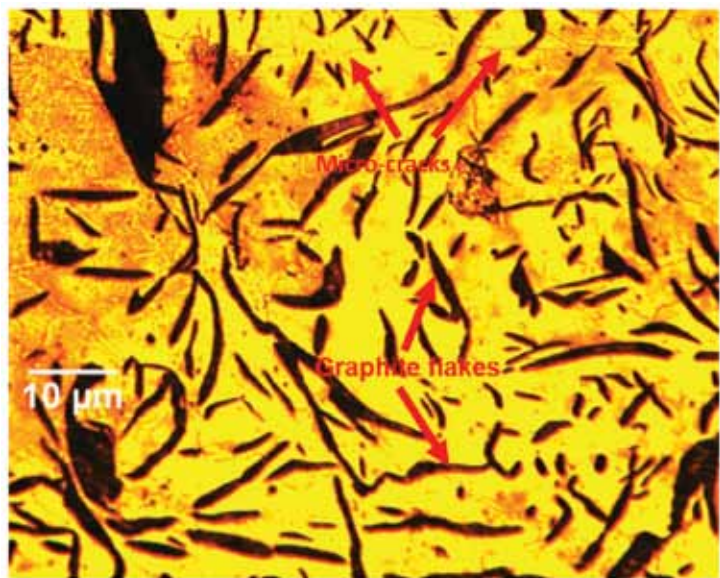
FIGURE 14
Microstructure of rusted surface.

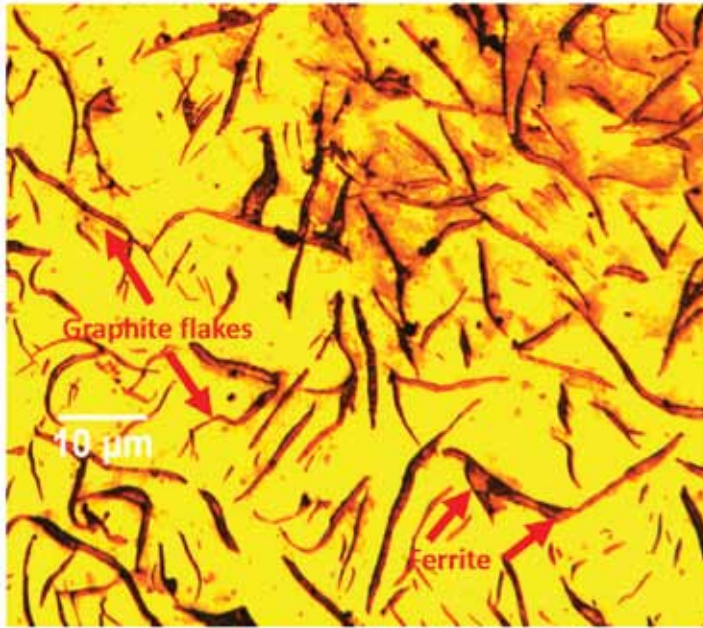
FIGURE 15

Microstructure of a laser-cleaned surface (60W of laser power, 900mm/s traverse speed, spot size of 0.72mm).

The laser-cleaned sample has a relatively larger spacing between the flakes when compared to the un-rusted and rusted surfaces. An increase in space between flakes results in an increase in the strength and a corresponding increase in hardness. A relatively shorter flake length and smaller flake size yields a higher hardness value when compared to the un-rusted and the rusted surfaces. This is because graphite particles are generally softer. The hardness is evident as seen on the microstructure of the laser cleaned surface in Figure 15. There is a relative decrease in the number of graphite flakes when compared to the microstructure of the rusted grey cast iron sample. Furthermore, a denser cluster of graphite flakes with relatively bigger flake size and longer flake
