# Development of Combined Seam Tracking and Process Monitoring for Laser Welding

Light emitting diode (LED)-based process zone illumination and coaxial imaging using a matching narrow bandpass filter give images of a sufficient quality to be used in a novel seam tracking and process monitoring laser welding tool. Features of the image can be determined every 10 ms. Variations in the features imaged (area, aspect ratio and centre position), along with changes in the noise levels of photodiode-monitored process emissions, allow for the detection of welding process defects, including contamination of the cover slide, joint gaps, incorrect settings of beam focus or gas shielding flow rate, and loss of full penetration on loss of power or an unexpected increase in material thickness.

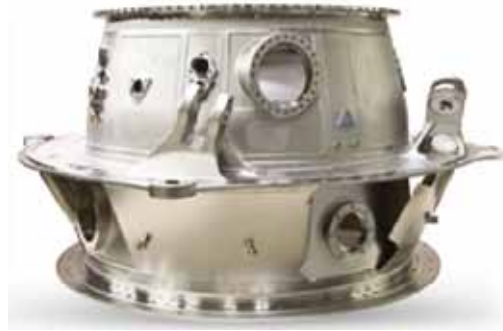
FIGURE 1

Example photograph of a complex aerospace structure incorporating laser welds (Courtesy of GKN Aerospace).

As a low distortion and high performance means of joining, laser welding can offer significant advantages when manufacturing high value, safety critical applications (see Figure 1). Narrow process tolerances, however, can make it a challenge to maintain weld quality. Failure to monitor and control part preparation and cleanliness, part placement, seam location and fit-up, and the parameters of the process itself can all result in weld defects.

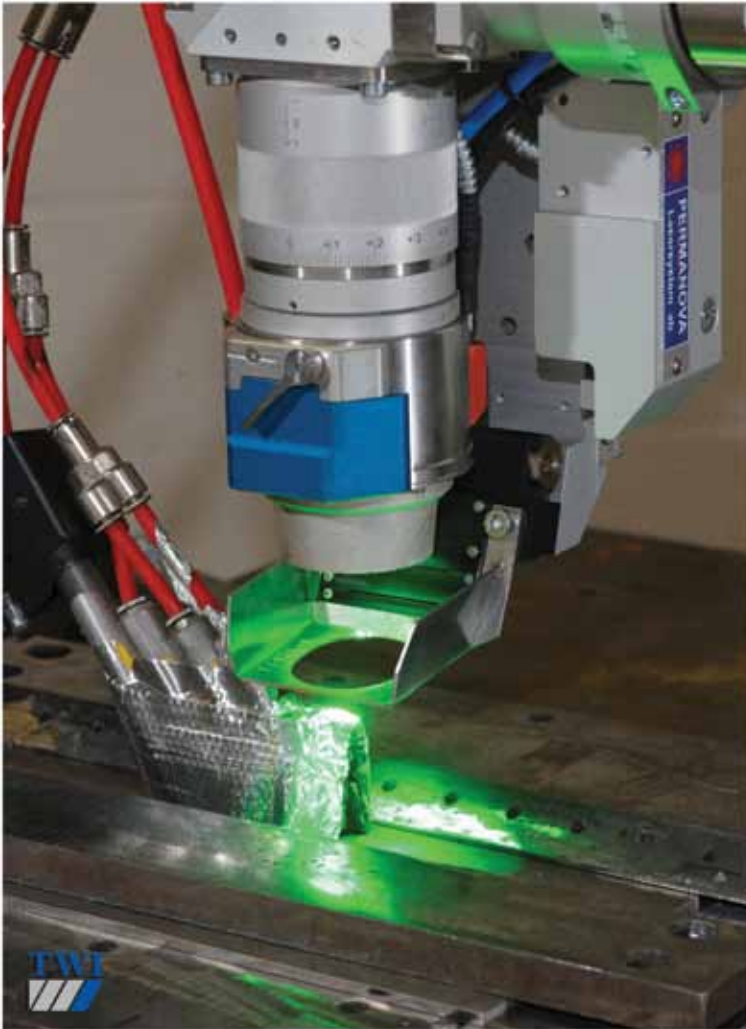
FIGURE 2

Photograph of the laser welding head with built-in LED illumination developed by Permanova.

fitted coaxially to the head of a Yb:fibre laser (YLS-10000; IPG Photonics Corporation) set up for welding, as shown in Figure 2. Figure 3 shows three camera images which are typical examples obtained with appropriate LED illumination settings and exposure times. With this hardware in place, image analysis software was then developed by Bit Addict. As Figure 3 shows the seam location can be resolved in such images. Analysis in this area of each image could successfully detect the seam. The co-ordinates of its location can then be fed to a side-to-side actuator, fitted between the welding head and its

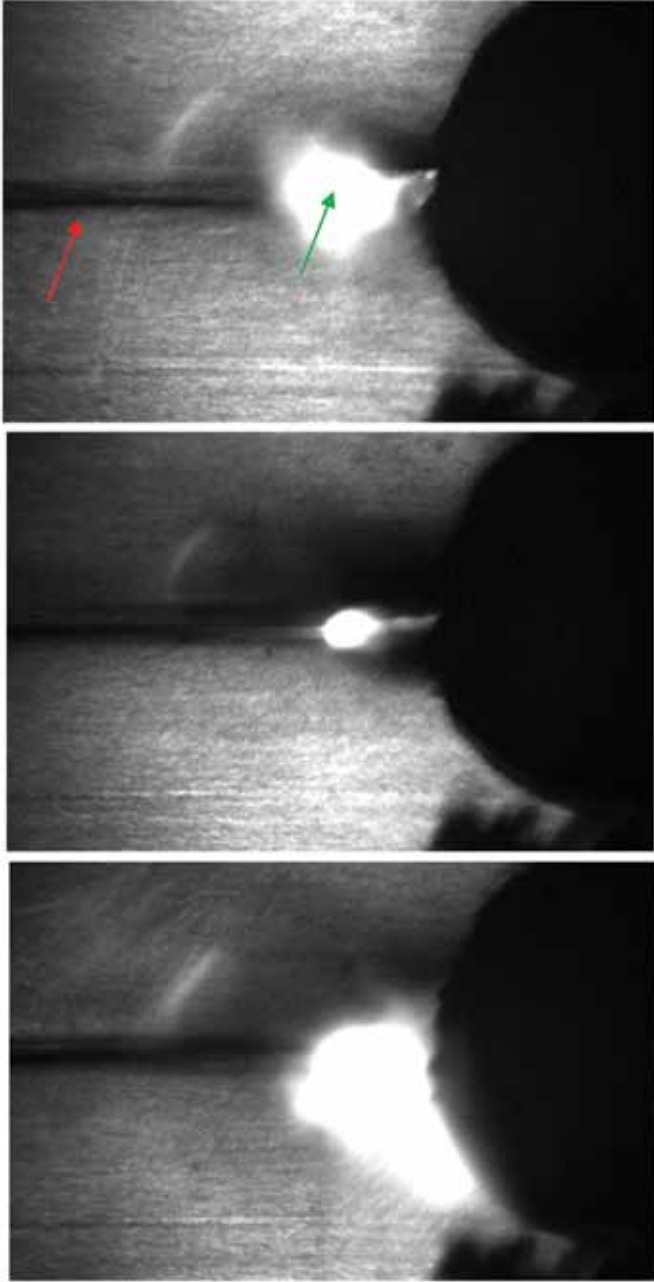
FIGURE 3  
Three camera images showing seam location (red arrow) and features of the laser beam-material interaction (green arrow).

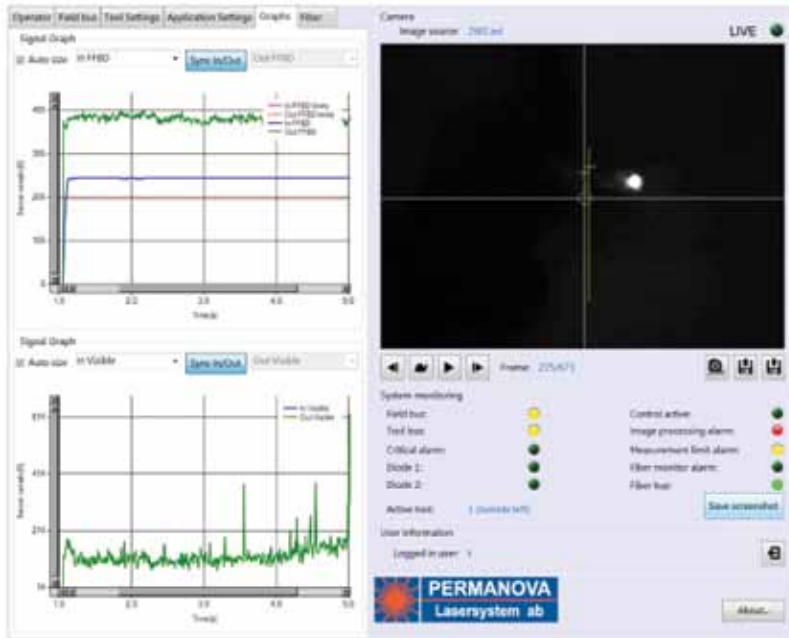
FIGURE 4

Laser weld monitoring software: laser beam intensity at both input and output ends of fibre (top left), process light (bottom left), example of coaxial camera image (top right) and system status (bottom right).

This work concentrated more on using the camera images as a source of process monitoring data. Additional image analysis routines were developed to extract the area, aspect ratio (or circularity) and centre co-ordinates (in  $x$  and  $y$ ) of the bright pixels associated with the point where the beam impinges on the material being welded. Additional areas of bright pixels, arising for example from the ejection of spatter droplets from the keyhole during welding, could also be detected and quantified by this software. Software to monitor and control these algorithms was also developed by Bit Addict, including options to monitor and record data coming in from other process sensors, as well as optics temperature and/or scattered light readings. In the work reported here, the other process sensors used alongside the camera were photodiodes monitoring the intensity of any back-reflected  $1\ \mu\text{m}$  wavelength laser radiation, as well as any visible process light itself. This monitoring software could run in near real-time on an industrial personal computer (PC) (with analysis results coming back every 10 ms). Figure 4 shows an example of some of the software screens.

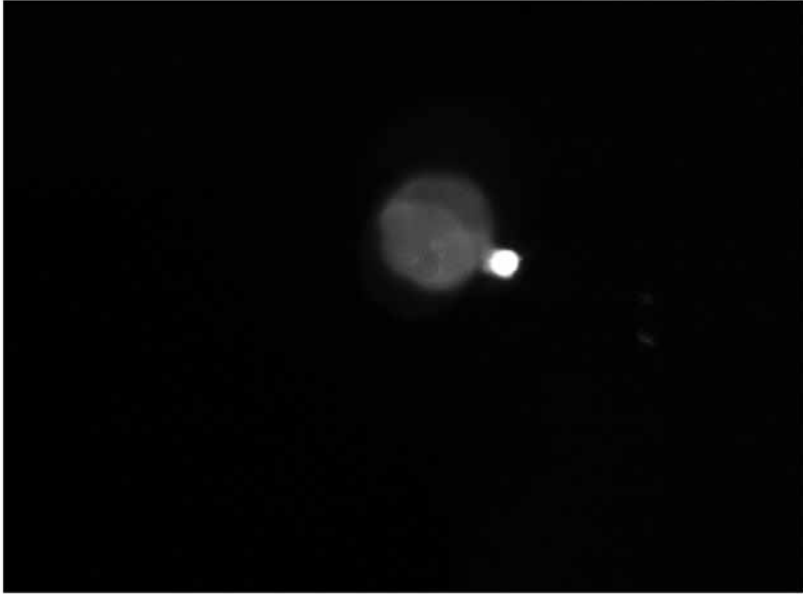
FIGURE 6  
Image with contaminated cover slide.

Figure 6 shows the effect on such images with the occasional scattering of process light that can be seen when the cover slide begins to become contaminated. Figure 7 shows the process light that can be scattered down an unacceptably wide joint gap, then being detected by the coaxial camera. With a change in beam focus position, a change in the size of the camera image is also apparent, as shown in Figure 8.

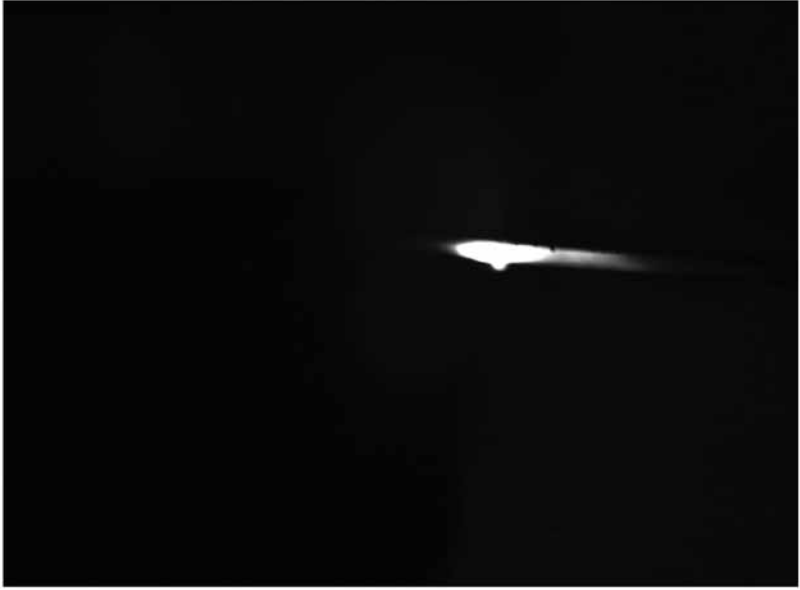
FIGURE 7  
Image of unacceptably wide joint gap.

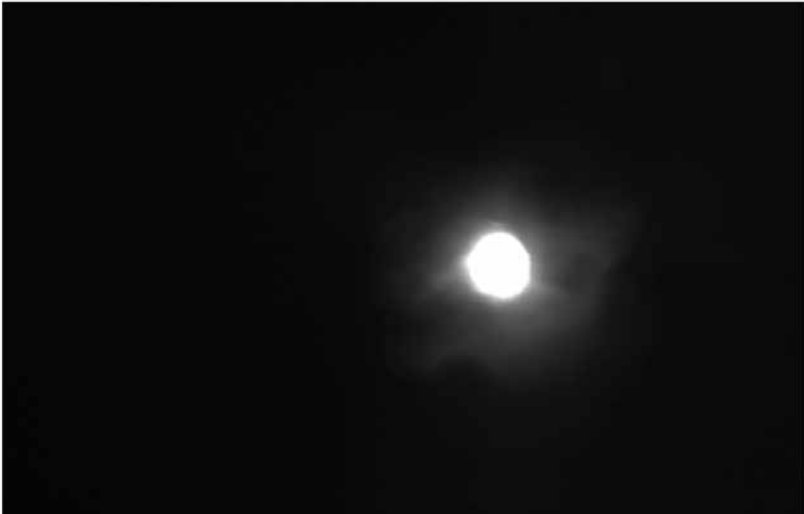
FIGURE 8  
Increase in image size with change in beam focus.

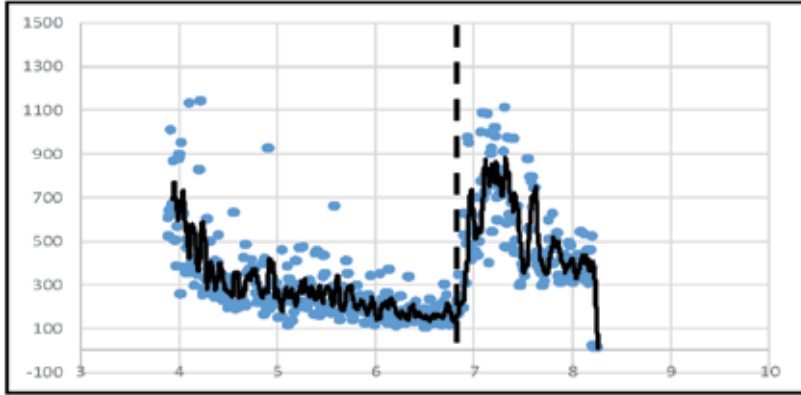
FIGURE 9  
Spike in-process light emitted on loss of gas shielding.

A change in gas shielding settings was one of the few things investigated that, although affecting weld quality, did not bring about an easily visible change in the camera images. Instead, the significant increase in the levels of process light associated with a reduction in gas coverage of the processing zone were more readily detected using a photodiode, as shown in Figure 9, which plots emitted process light intensity with time.

Figure 9 showed how a shut off in gas shielding could be detected using a photodiode monitoring process light. Figure 13 shows similar results, showing how the noise of this photodiode signal increased when using non-optimum gas shielding levels. Figure 13 shows what happens when using inadequate gas shielding, but the same increase in photodiode signal noise level was also seen when using an excessive gas shielding flow rate.

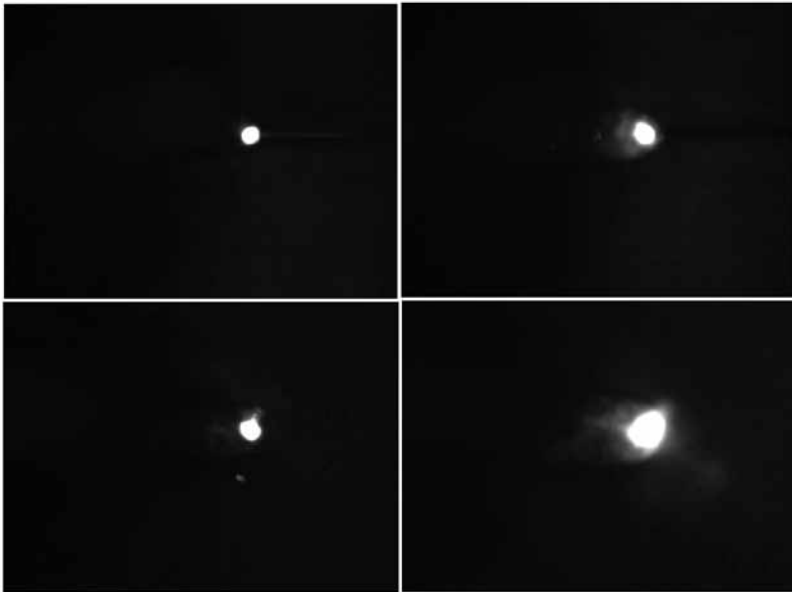
FIGURE 10  
Change in image on loss of penetration with either a power change (top left and top right) or material thickness change (bottom left and bottom right).

More subtle variations could be picked up in the size, shape and stability of the image on loss of penetration, either resulting from a deliberately introduced reduction in laser beam power or from an intentional change in work-piece thickness, as can be seen from Figure 10.

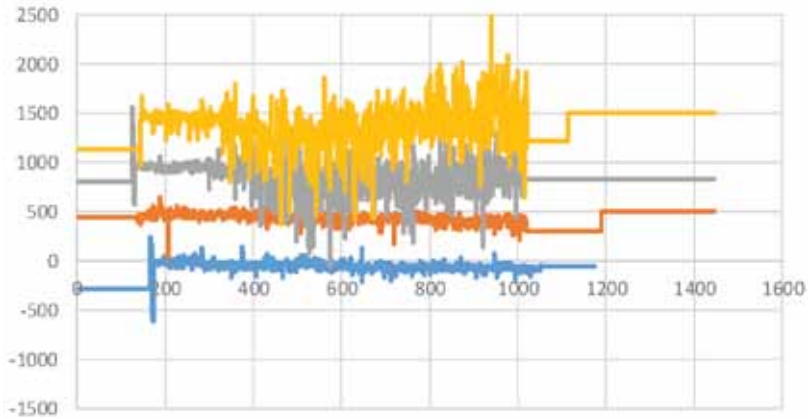
FIGURE 11

Change in x co-ordinate of image centre over the course of four welds with increasing cover slide contamination (bottom trace to top).

Figure 11 shows how the value of the x co-ordinate of the image centre became less stable with increasing cover slide contamination. This was presumably due to a gradual reduction in laser power arriving at the work surface and a corresponding reduction in process stability. Figure 12 shows how monitoring of this same parameter can also pick up changes in beam focus position resulting in process instabilities leading to variations in bead width or spatter. A similar result is achieved in this case when monitoring the aspect ratio of the image, which becomes more elliptical, and less stable, when using a non-optimum focus setting.

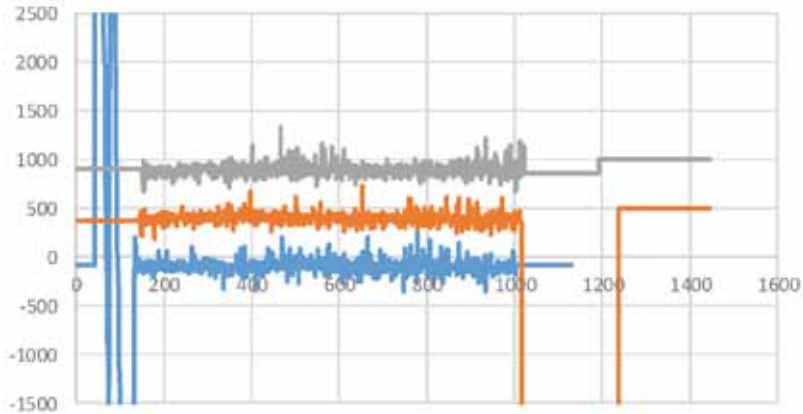
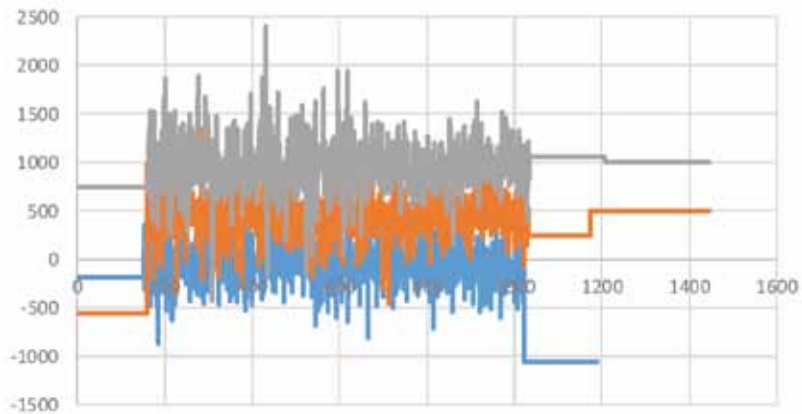
FIGURE 12

Plots of x co-ordinate of image centre for three experiments with (a) optimum beam focus setting and (b) non-optimum.

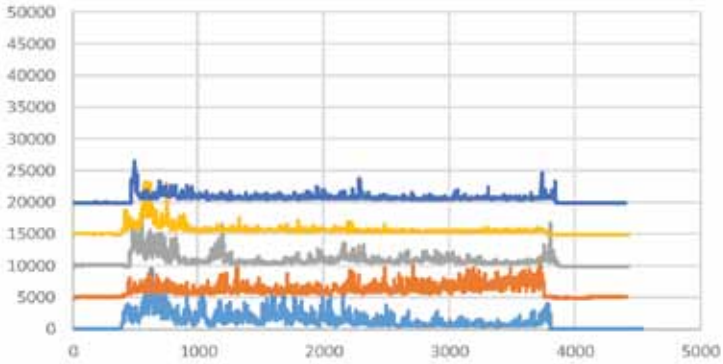
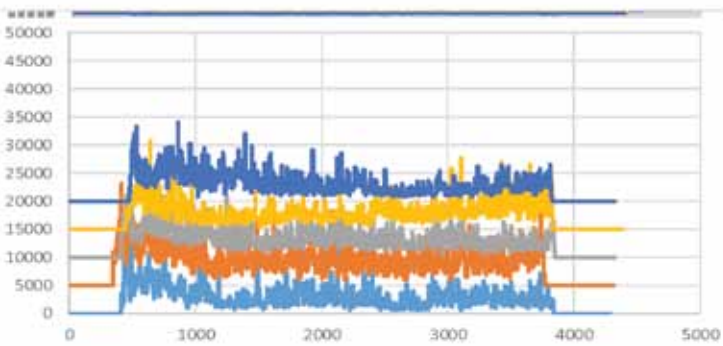
FIGURE 13

Increase in process light noise between (a) five optimally shielded experiments and (b) five inadequately shielded.

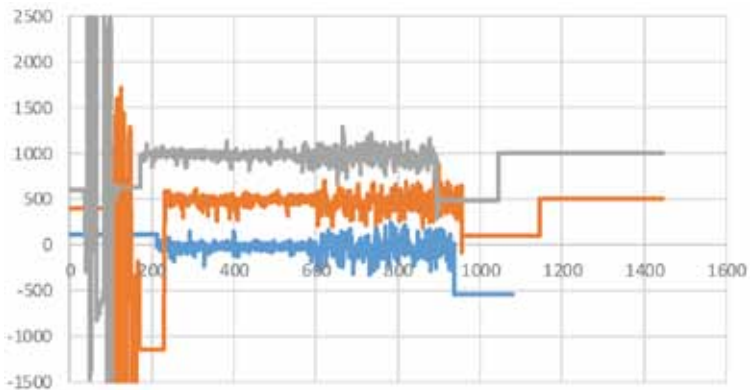
FIGURE 14

Increase in instability of x co-ordinate of image centre for three experiments welding over a step increase in material thickness, resulting in loss of full penetration.

Figure 14 confirms the detection of the reduction in the positional stability of the image on loss of penetration. Corresponding increases were also seen in the value, and noise level, of the aspect ratio of that same image.

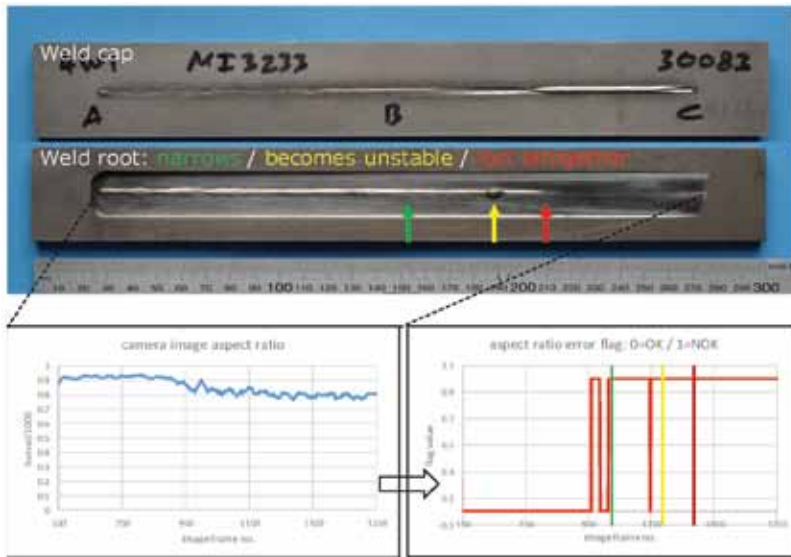
FIGURE 15

Welding of the wedge-shaped coupon (top) resulting in progressive root narrowing, instability and then loss of penetration. Corresponding reduction in image aspect ratio value and increase in its noise level (bottom left). Associated flag behaviour (continuous red line), compared to the behaviour of the weld root (vertical green, yellow and red lines in bottom right).

variable was set to trigger (by changing from 0 to 1) when the aspect ratio fell below the pre-set lower bound value. Figure 15 shows the result from one such experiment, showing that the flag variable already triggers just prior to the weld root starting to narrow, and remains consistently high (at 1) thereafter as penetration becomes unstable and is then lost.

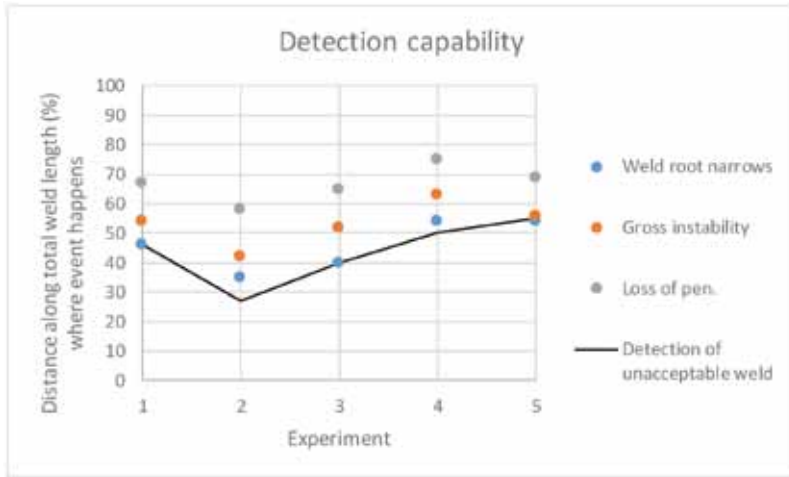
FIGURE 16

Comparison of flag trigger distance along five coupons with weld root narrowing, instability and then loss of penetration occurred in each.

Figure 16 compares this first trigger point along the length of the weld with these same three changes in weld root behaviour for five experiments. This indicates good reproducibility in using this method as a means of detecting loss of penetration.
